**WATERPROOFING SPECIALISTS AND CONTRACTORS
WITH GEOMEMBRANES**

UNDERWATER INSTALLATION

WATERPROOFING OF HYDRAULIC STRUCTURES

**Providing Dry
and Underwater Installations**

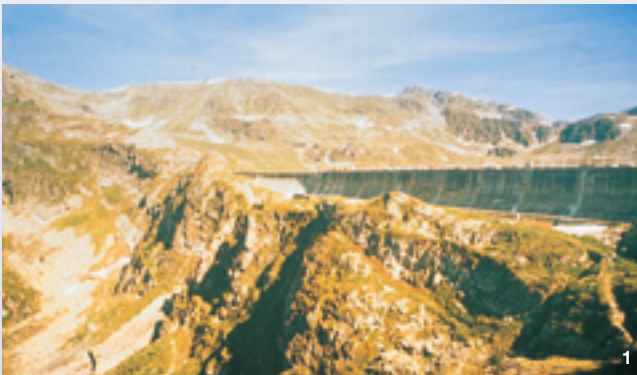
1 - Illsee dam (Switzerland) before intervention.

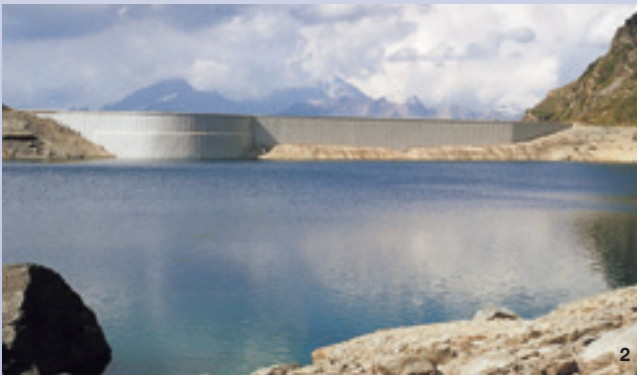
2 - Illsee dam (Switzerland) after intervention.

The above benefits are achieved by installing a continuous impermeable barrier from the crest to the heel of the dam. The barrier can be connected with the foundation and the grout curtain. A continuous face drainage system installed between the waterproofing geomembrane and the dam face collects and discharges the water from seepage and dehydration.

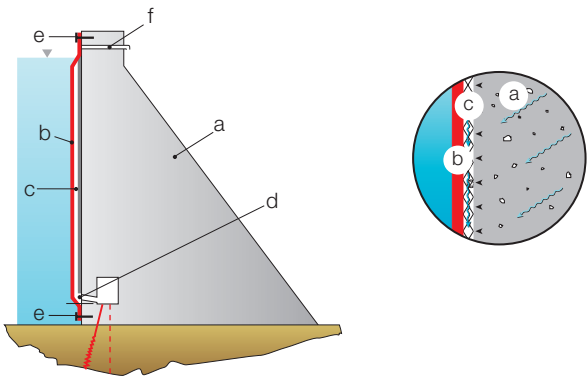
CARPI patented steel profile fastening system pretensions the geomembrane insuring geomembrane will remain taut even in dewatered conditions.

- a. Dam body (high permeability)
- b. CARPI waterproofing liner
- c. Vertical anchorage and face drainage for geocomposite (high transmissivity)
- d. Perimeter drainage collection system
- e. Perimeter seals
- f. Ventilation pipe (optional)

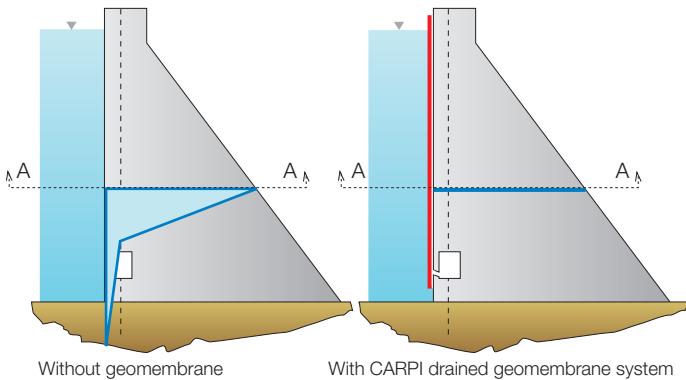
COMPARING UPLIFT AT CURRENT SECTION OF DAM

Since the entire surface of the geocomposite is not attached to the dam face, the system allows drainage of any seepage water, thus providing full effective reduction and control of uplift in the dam body. Additionally, water saturating the dam body will exit through the drainage system, dehydrating the dam body improving the stability factor.

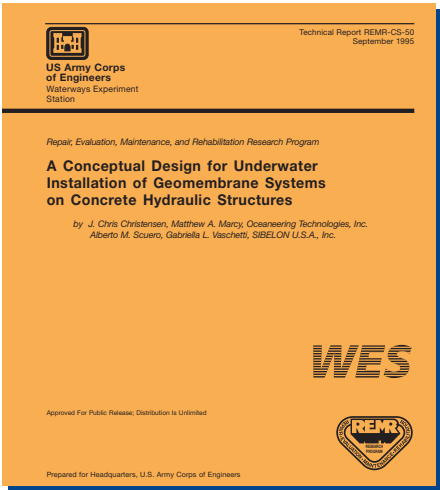
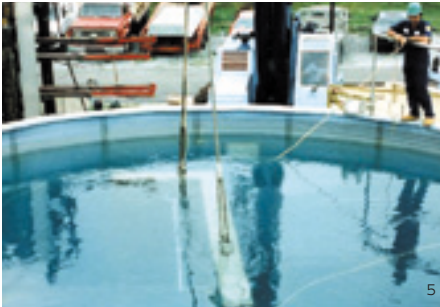
5 - The test structure used for underwater testing of the CARPI system.

The adapted system was developed and demonstrated on a test structure which simulated features likely to be encountered while repairing an actual hydraulic structure (i.e., rough surface, construction joints, complex corners, etc.). Furthermore, the study investigated 21 geomembranes and geocomposites (HDPE, EPDM, CSPE, PP, PVC, etc.) for various properties at varying water pressures. The CARPI PVC geocomposite received the highest ranking from testing as demonstrated by pictures to the right. The efficiency of the CARPI synthetic membrane system was tested at various hydrostatic heads.

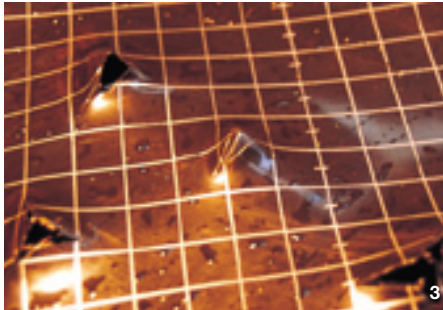
3 - HDPE after rupture at 0.15 MPa with poor conformability.

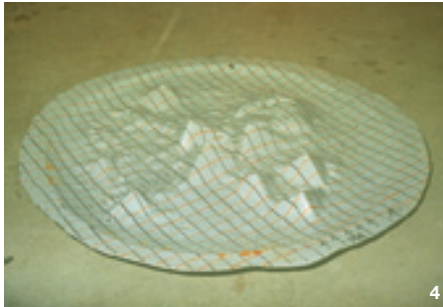
4 - CARPI PVC after 24 hours at 1.0 MPa with good conformability and no failure.

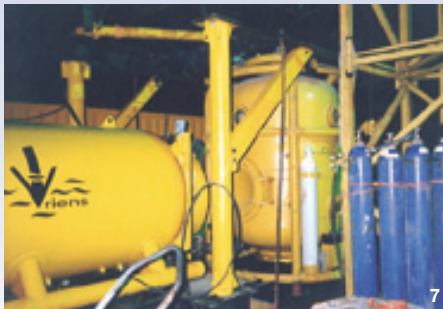
7 - Diving bell and decompression chamber.

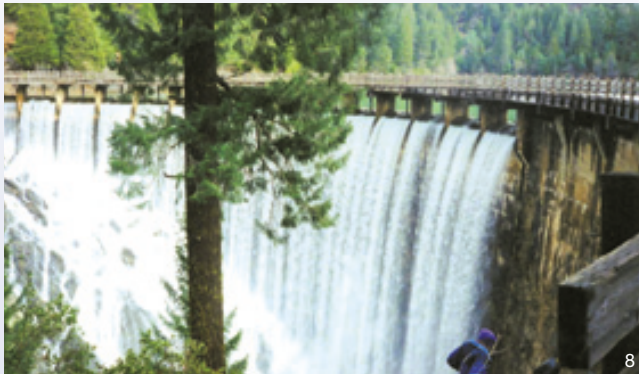
8 - Lost Creek Dam pictured is a thin arch concrete dam built in 1924 that is 36 meters tall with a crest of 134 meters. The dam is located in the mountains of California at an elevation exceeding 950 meters. The concrete in the dam was porous so that seepage was occurring across the entire upstream face.

Prior to rehabilitation, the downstream face of Lost Creek Dam was wet and saturated due to seepage, and as a result it had suffered freeze/thaw deterioration.

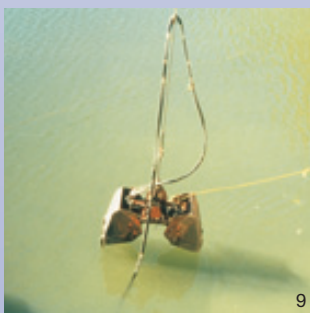
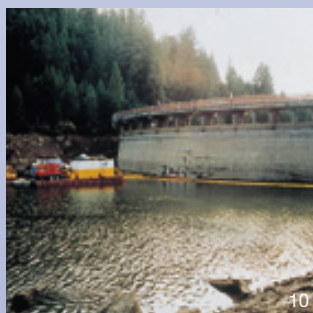
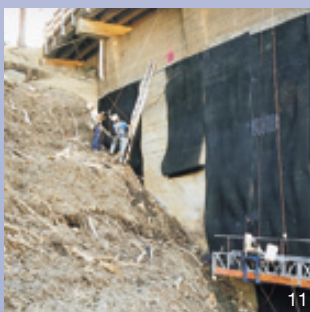
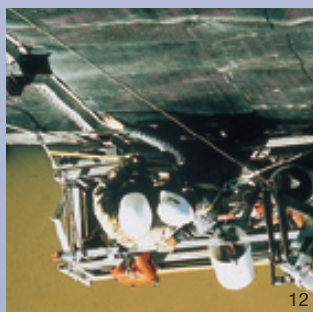
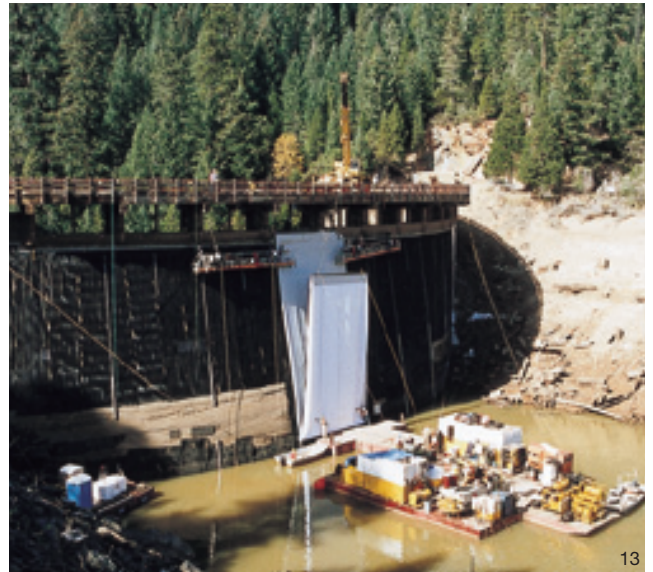
- 9 - The reservoir at Lost Creek Dam with the Oceaneering diving crew dredging upstream of the dam foundation in preparation for geomembrane installation.
- 10 - The upstream face of Lost Creek Dam on September 18, 1997 as the crews begin work on face repair, perimeter seal, and geonet installation.
- 11 - The first task of the waterproofing system was the installation of a geonet drainage layer on the entire surface of the dam face.
- 12 - The geomembrane is installed and attached to vertical anchorage as pictured. Then the perimeter seal at the dam foundation is completed.

13 - Installation of the first panel into the water. This process requires close coordination between the above water crew and the diving crew. The geomembrane must be deployed by crane from the crest of the dam, unrolled and then aligned before lowering into the water.

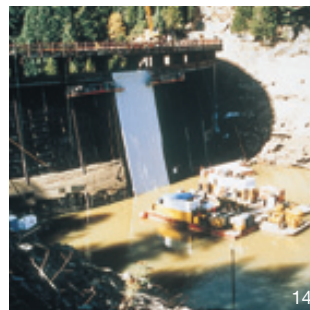
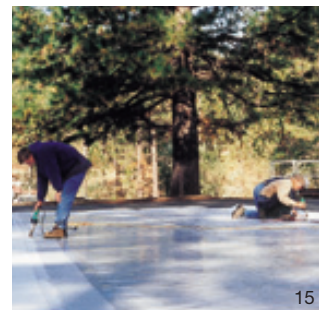
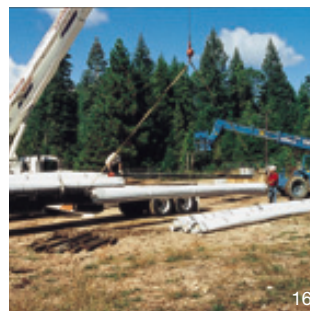
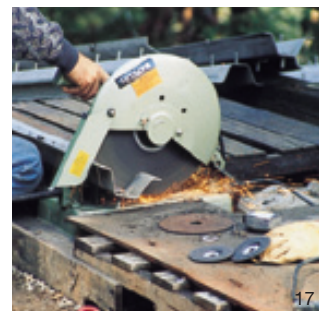
- 14 - The geomembrane roll completely deployed with divers beginning underwater attachment. It is important that the panels are properly aligned prior to lowering into the water because the divers are working with limited visibility.

- 15 - In order to insure a watertight seal at the perimeter of the geomembrane installation the geotextile must be removed from the backside to prevent a wicking action of water. In the picture above the crew is stripping the geotextile to match the dam foundation following the underwater survey after completion of dredging.

- 16 - Each roll of geomembrane weighed more than 900 kilograms. Therefore, to stage the rolls required careful planning as it required a large forklift, boom truck, tractor-trailer, and several people to move the rolls.

- 17 - Many dams such as Lost Creek have curvature from the top to the bottom of the face. This complicates the installation of the vertical geomembrane attachment hardware where two panels of geomembrane overlap. CARPI custom sawcut each piece of attachment hardware to conform to the curvature existing at Lost Creek Dam and then ground the hardware to insure a flush, smooth support for the overlapping geomembrane panels to insure a watertight seal.

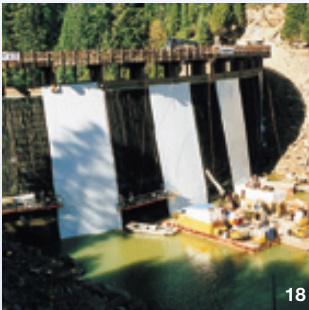
- 18 - The 8 meter wide geomembrane panels were deployed in alternating sections to insure proper alignment and evenly distribute work for the crews above and below waterline.
- 19 - The CARPI crew performing the above water installation from suspended platforms. The crew is installing the top perimeter seal just below the pillars of the bridge.
- 20 - The crew preparing to deploy a geomembrane panel near the left abutment. The white geotextile material underneath the black geonet covered rough spots on the dam face negating the need for concrete face repairs.
- 21 - Pictured is the conduit installed behind the geomembrane to measure the water level in the drainage layer placed on the upstream face. The water level in the drainage layer is one of the acceptance criteria for the project. Readings from the piezometer have continuously shown the dam face is completely dry.

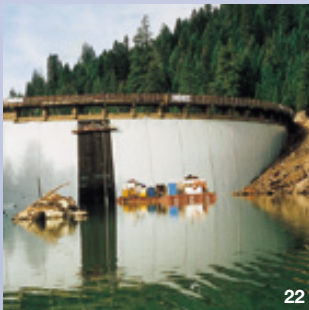
- 22 - The geomembrane installation is nearly complete as the crew prepares to deploy the panel in the deepest portion of the reservoir over the piezometer conduit for measuring the water level in the drainage layer behind geomembrane.
- 23 - Oceaneering divers at the air/water interface installing the perimeter seal anchor bolts along foundation.

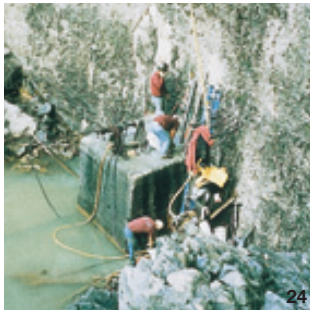
- 24 - The drainage pipe for the drainage layer behind the geomembrane was installed by drilling through the dam from the downstream face and grouting a pipe in place. The picture shows the crew preparing to drill through the dam.
- 25 - The project was completed on November 26, 1997 with more than 25% of the work performed underwater. Underwater installation was the only option, as the reservoir could not be dewatered for environmental concerns. Pictured is the geomembrane installation completed on November 26, 1997, while the crew is beginning demobilization approximately 2 months after the geomembrane installation began on the 2,600+ square meter surface.

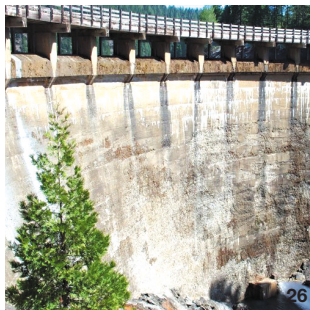
26 - Eliminating the water contacting the upstream face has halted the freeze/thaw deterioration. As reported by Richard Harlan, Consulting Engineer to OWID, *"Successfully sealing the upstream face of a dam to reduce leakage and mitigate downstream face deterioration without dewatering the reservoir has been a dream of dam engineers for many years. Even though the underwater geomembrane installation at Lost Creek Dam in 1997 was unprecedented, it was completed on schedule (critical, because it had to be done during a scheduled power outage). The work also was completed for the originally quoted budget.*

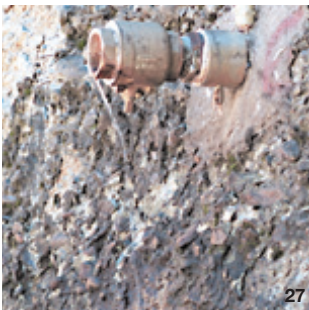
- 27 - The second acceptance criteria was measuring the water flow from behind the geomembrane. The photo provided by Richard Harlan, Consulting Engineer to OWID, in November 2002, shows the total seepage after 5 years of installation. The Lost Creek geomembrane installation received the 1998 ASDSO West Region Award of Merit and the 1999 Hydro Achievement Award from the NHA.
- 28 - 1997, before works. The downstream concrete was so deteriorated that it could be removed with a hand pick down to a depth of > 30 cm.
- 29 - 2002, after works.

"Latest measurement, November 2002, of leakage through the entire 2,600+square meters of membrane covering the entire face of the dam, is only 0.22 gallons (0.8 liters) per minute."

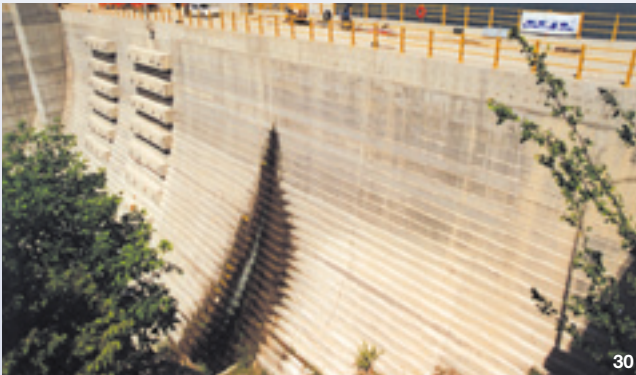
30 - Platanovryssi Dam in Northern Greece, constructed in 1998, at 95m is the highest RCC Dam in Europe. As described by the Public Power Corporation of Greece (PPC), owner of the dam, in the article "Seepage evolution and underwater repairs at Platanovryssi", Hydropower & Dams, Issue Six, 2002, *"The faces of the dam are not considered to be the impermeable membrane; the RCC placed between the facing elements in the center of the dam is designed to be the water barrier."* Cracks in the facing were anticipated, but they were not expected to propagate into the body of the dam, which was designed to be impervious. The contraction joints in the dam are at variable centers, generally no more than 30 m. During construction of the dam these joints were sealed with an external waterstop system, the patented CARPI system for waterproofing of joints, consisting of a PVC geocomposite placed over three sacrificial geosynthetic layers. The external waterstop system, used in alternative to the conventional PVC waterstops embedded in concrete, was designed and tested to resist a joint opening of 25 mm, under a hydraulic head of 200 m. As reported by PPC, *"The initial expectation for the long term seepage at Platanovryssi was 5 to 10 l/s. The pool level was reached on 14 November 1998. For one month, through until mid December, seepage was 11 l/s. After mid December 1999, total seepage started increasing and reached more than 21 l/s at the end of May (...) followed by a maximum of 30.56 l/s on 10 October 2000 (...). In fact, what happened was that a crack, parallel to the flow, started to form at station 101, practically in the middle of one of the shorter dam monoliths, on the left abutment. At first it was noticed as a hairline crack on the upstream wall of the upper gallery, which developed and appeared in the gallery walls, ceiling and floor, and then on the upstream face and downstream face, producing leakage both in the gallery and through, reaching the downstream face."*

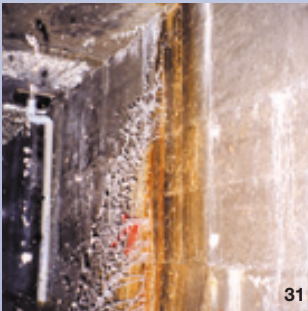
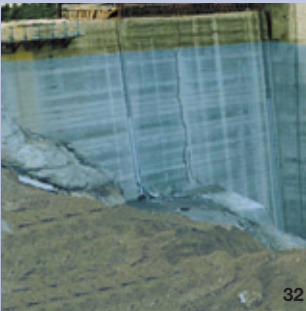
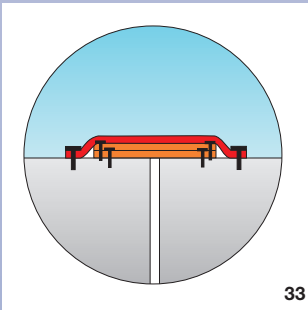
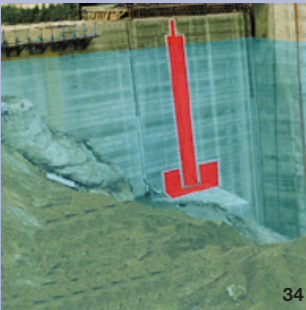
31 - Pictured is water leakage inside the gallery. Subsequent to increase in leakage, an underwater survey was conducted to ascertain the dimensions and extension of the crack. Inspection revealed a crack starting from the crest of the dam, then dividing into 2 cracks, running nearly 2 m apart from each other. The crack extended from elevation 227.50 m to elevation 208 m, with a maximum width of 25 mm.

The dimensions of the crack increased and decreased under temperature changes through the year. As reported by PPC

"Leakage attributed to the crack alone reached values of almost 20 l/s both on February 2000 and February 2002. Lowering the reservoir to fix the crack would have been unthinkable, because not only Platanovryssi would have to be out of service for several months, but also the pumps at the much larger Thissavros scheme upstream would have been affected, causing serious implications for the production system."

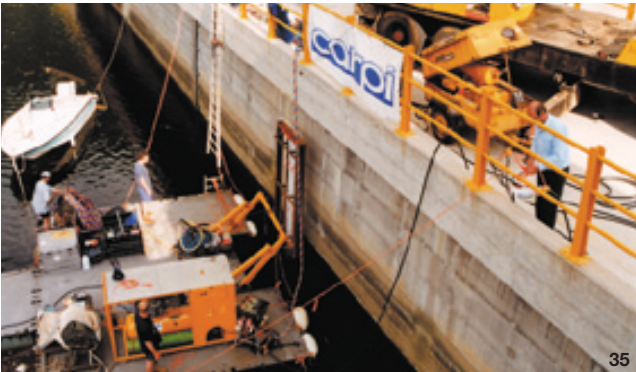
35 - The waterproofing system was installed in the dry from crest level at 227.50 m to elevation 225 m, and underwater from elevation 225 m down to elevation 208 m. The final design and the underwater works were accomplished with the services of the associated specialist contractor Viens Diving International BV (Holland).

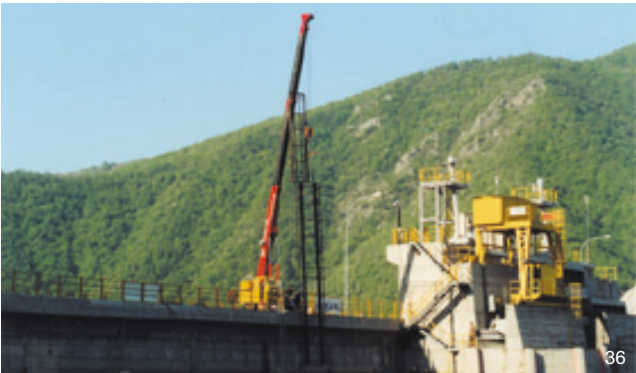
36 - A multipurpose drilling template was constructed to facilitate underwater installation.

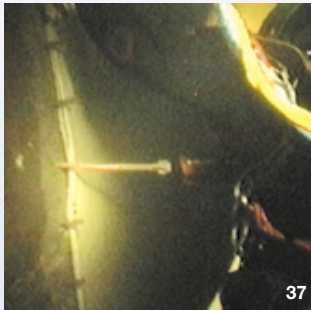
37 - The template is used to exactly position the holes for the perimeter bolts, and as a scaffolding to hold the divers in position while performing underwater drilling, cleaning with high pressure water jet, and installing the CARPI system.

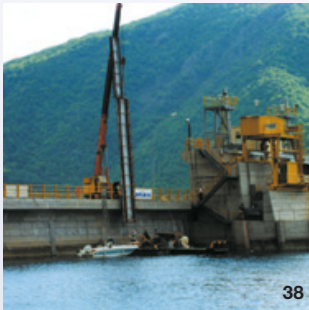
38 - The sacrifice PVC geocomposite sheets are cut and assembled so as to be lowered into the water in one single big “patch”, covering the path of the fissure. Pictured is the drilling template used to lower into position the sacrifice fissure layers.

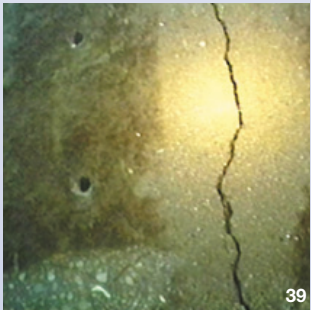
39 - The sacrifice layers span the area over the fissure that is within the perimeter seal.

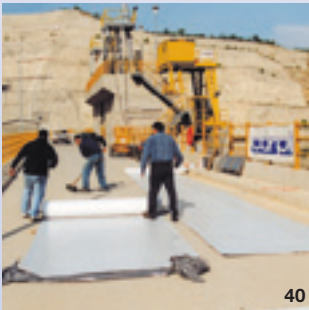
40 - The waterproofing PVC geocomposite sheets are cut and assembled in one single big “patch”, corresponding to the red area in figure 34.

34 - The CARPI PVC geocomposite system (the red area) follows the path of the cracks to totally cover them.

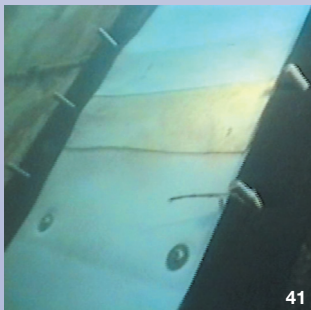
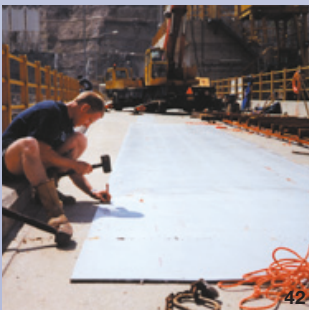
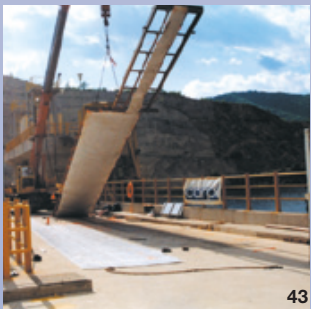
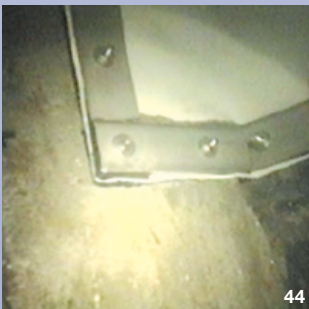
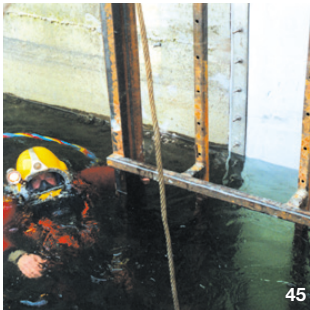
41 - The rubber gaskets for the perimeter seal are placed over the concrete surface regularized by grinding, to achieve a better seal. Pictured are the sacrifice geocomposites attached to the dam face by impact anchors, and the rubber gasket punctured over the anchor bolts of the perimeter seal.

43 - The waterproofing PVC geocomposite placed on the drilling template is lowered to underwater position.

44 - The perimeter seal is made by puncturing the waterproofing PVC geocomposite over the anchor rods and by compressing it on the RCC with stainless steel batten strips and rubber gaskets.

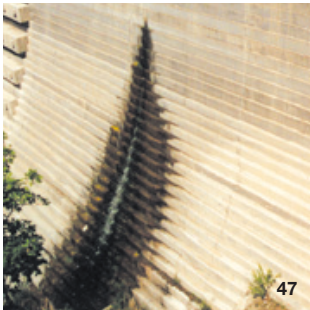
47/48

46 - The contract was awarded on April 11, 2002. Works started on April 22, 2002 and were completed on May 23, 2002. During this time, the divers also provided a full mapping and description of the crack, following it to a depth of 35 m below the surface. This crack, which is not seen on the downstream side as it is intercepted by the inspection gallery, is responsible for leakage still occurring in the inspection gallery, below elevation 208 m. Therefore, additional repair is now under consideration to stop the leakage at that level. Full mapping will allow PPC “to make a good estimate of further work needed to seal the crack completely down to its full length, which was some 15 m more.”

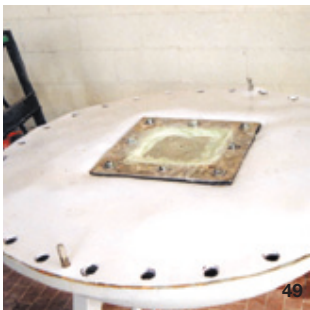
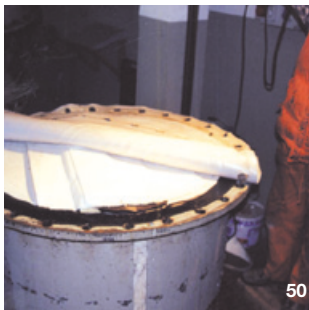
49 - The CARPI perimeter seal has been tested and approved by ISMES in a full scale test performed in a pressure vessel, applying water heads up to 25 bar.

50 - The configuration for the support layers has been tested and approved by ISMES in a full scale test performed in a pressure vessel, applying water heads up to 25 bar.

As reported by ISMES the tests “satisfied the specifications of the project”. The sacrifice layers avoid intrusion of the waterproofing geocomposite into the fissure and the CARPI system is watertight.

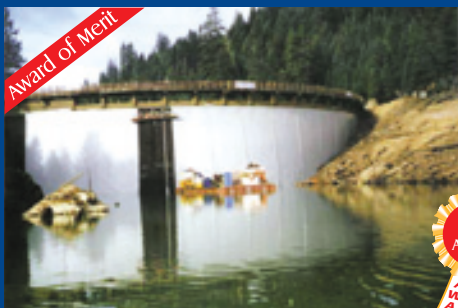
Underwater installation on Lost Creek dam - USA
 Winner of the 1998 West Region Award of Merit from the Association of State Dam Safety Officials (ASDSO)
