WATERPROOFING SPECIALISTS AND CONTRACTORS WITH GEOMEMBRANES

C A N A L S

WATERPROOFING AND INCREASING WATER FLOW

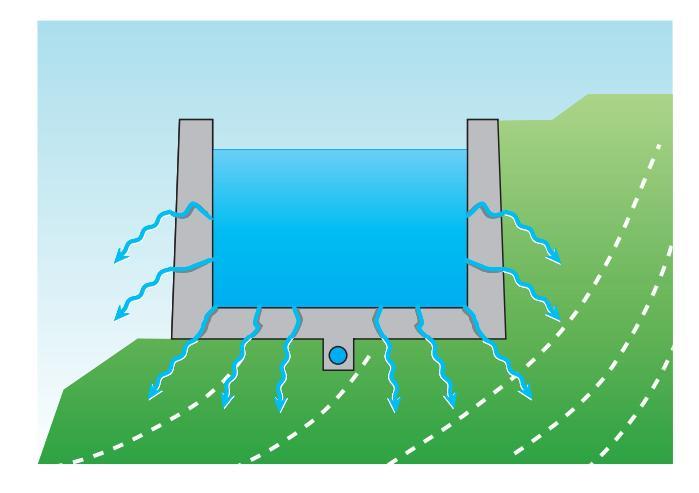
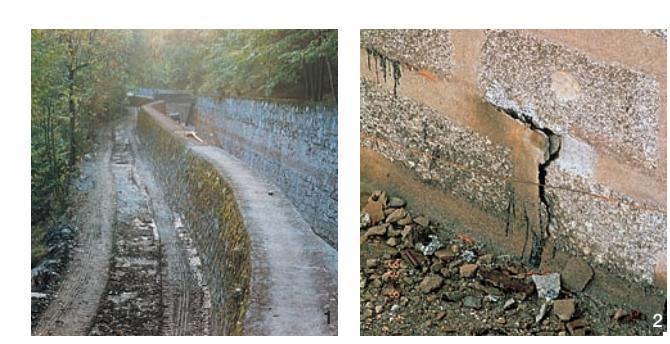
- 1/2 The aging of the joint sealing material results in water losses and water flow reduction.
- 3 The outcome can compromise the structural integrity of the canal and lead to very disturbing situations as pictured.

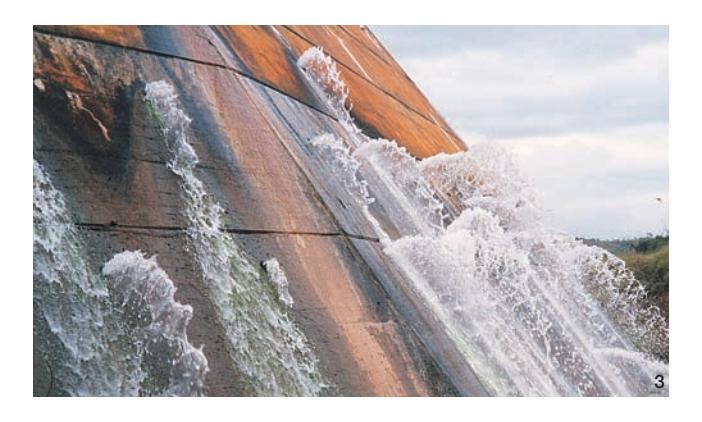
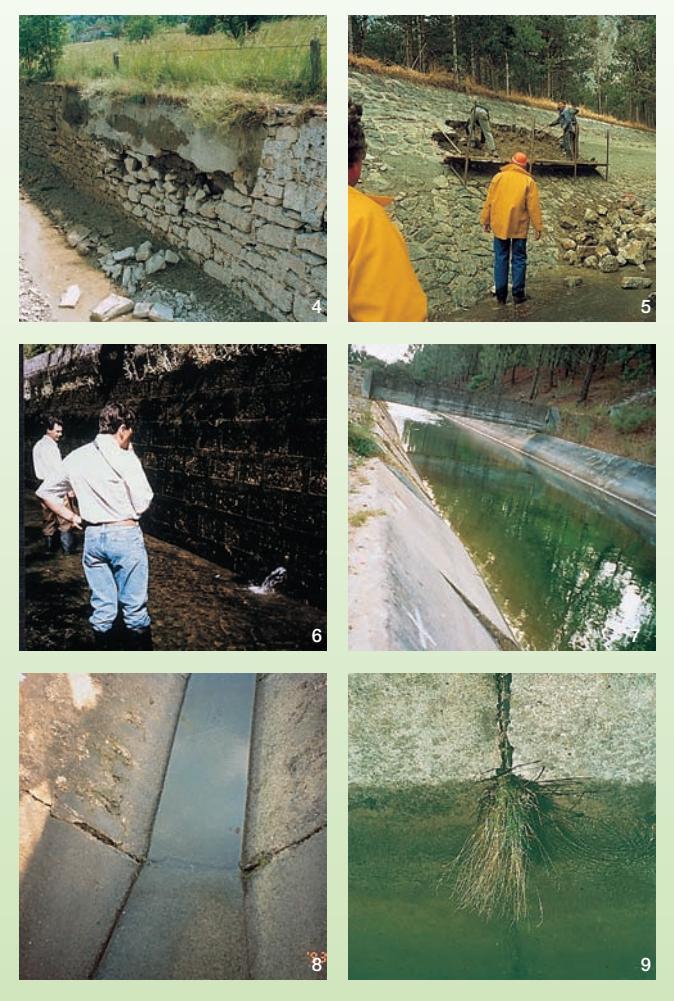
- 4/5 The canal structure and/or lining may collapse due to uplift pressure and freeze/thaw cycles.
- 6 Joint sealing detachment due to infiltrations from surrounding soil.7 Structural alteration due to settlement.
- 8/9 Deterioration of joint sealing material leads to water losses and water flow reductions.

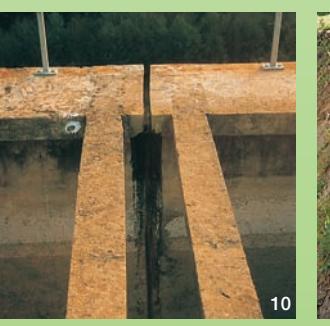
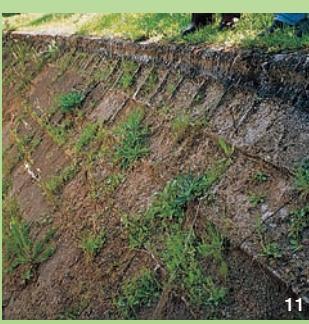
10 - Deterioration of joint sealing material in flumes increases water losses.
11 - Water flow is very abrasive and coupled to poor quality of concrete during construction results in the destruction of the original canal liner.

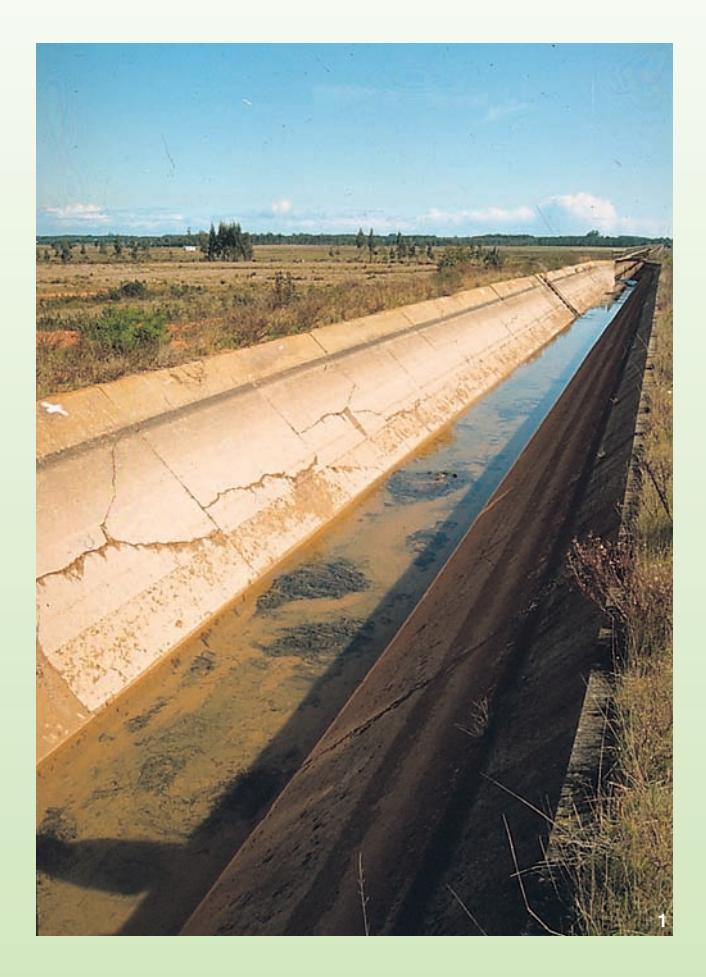
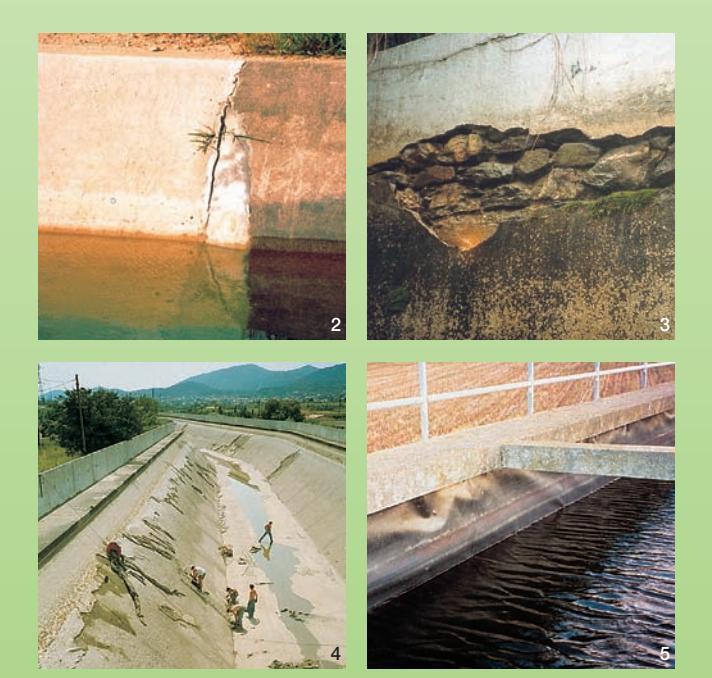
- 1 Cracks in structure provoke water losses and undesired water flows into surrounding soil.
- 2 Crack is caused by different expansion properties of existing canal concrete and new concrete used for repair.
- 3 Detachement of rigid lining material used for repair.
- 4 The powerful action of water flow and undrained water uplift pressures resulted in destruction of this bituminous membrane glued to the concrete after only 6 years of service.
- 5 HDPE liners are susceptible to high thermal expansion inducing stress cracking in liner and excessive stresses on liner anchorage system as pictured in this flume lined with a stiff HDPE membrane.

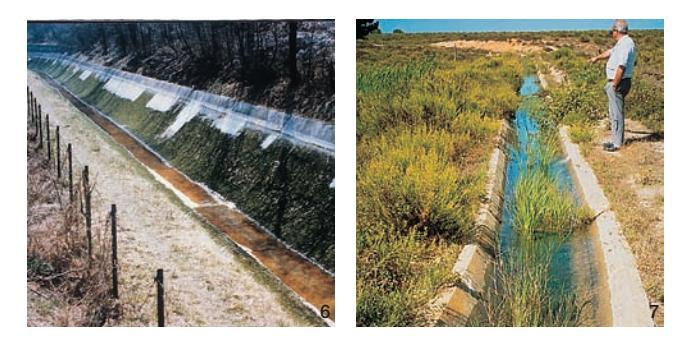
6/7 - The growth of moss and vegetation results in water flow reduction.

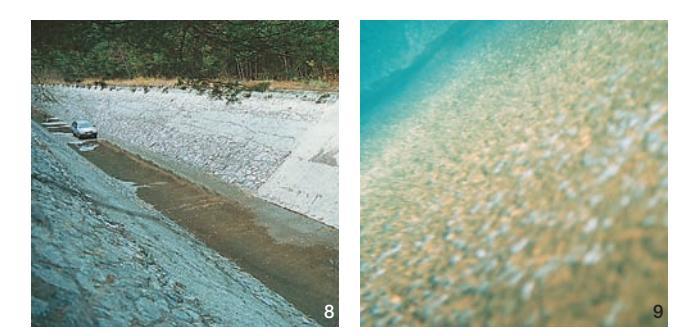
- 8 The fissures and permeability inherent with shotcrete used for canal repairs allow the water from the canal to continue to penetrate through the joints between the stones of the original structure.
- 9 Excessive roughness due to shotcrete or abrasion of old concrete increases friction losses.

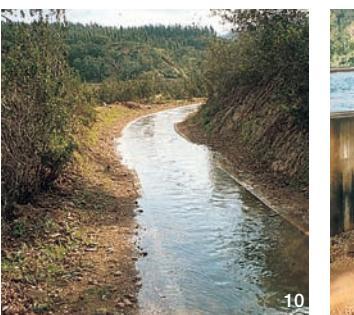
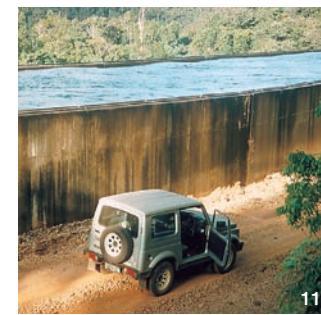
- 10 The result of either excessive roughness of the canal lining or growth of vegetation is a reduction in the design flow capacity of the canal.
- 11 Excessive roughness from the abrasion of the existing liner reduces the design flow. Overtopping of canal walls releases water into the canal's adjoining soil leading to instability of the canal foundation. The result is a high risk of collapse of the canal structure.

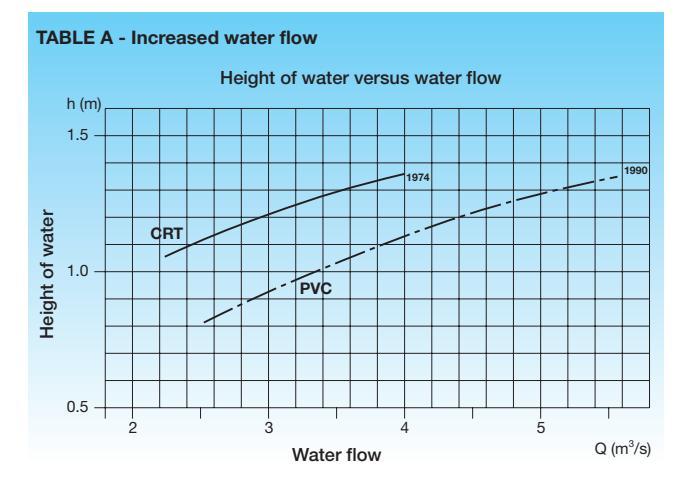
The existing hydropower canal has a rectangular cross section (width 2.5 m, height 1.5 m) and was lined with concrete (CRT). After only 6 years in service the canal water flow was measured and had fallen to 4.0 m³/sec with 1.35 m water depth (Table A, CRT curve). The owner decided to regain the original design flow and increase the total canal flow by installing a CARPI PVC geomembrane system. The CARPI PVC geomembrane system included mechanical fastening for geomembrane attachment allowing the PVC geomembrane to be left exposed on the inner section of the canal, dramatically increasing total canal flow. The canal flow was again measured after the CARPI PVC geomembrane system had been in service for 7 years. The new measurement indicated a flow, with a reduced hydraulic head of 1.30 m (Table A, PVC curve), representing a more than 40% increase in canal flow capacity.

In other cases, increases of up to 90% in canal water flow have been documented with a value of "n", the coefficient to be used in the Manning (Gauckler-Strickler) formula, of less than 0.0115. This value is a global figure for the entire canal and is not related solely to the geomembrane material.

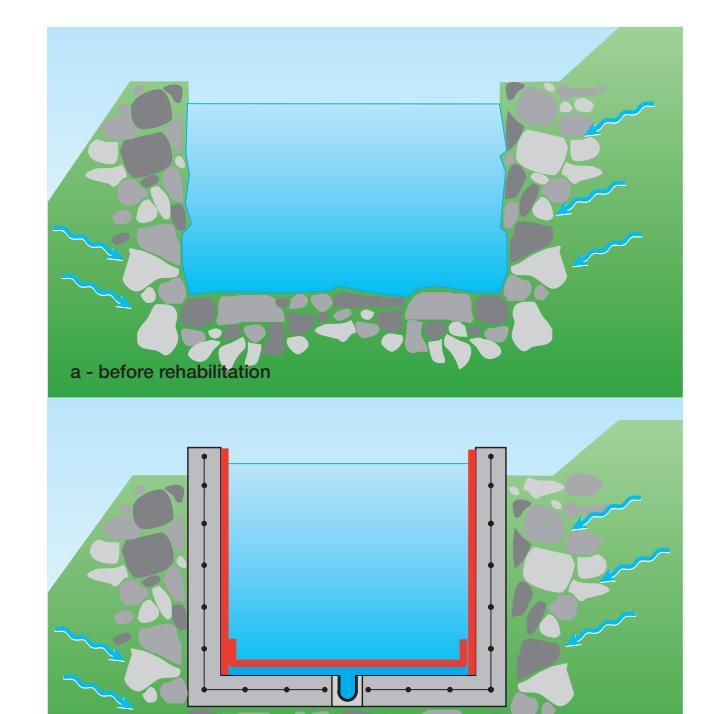
TYPE 6 - SIBELON CL - See also Construction, photographs 13-14

b - after rehabilitation and upgrading

Badly deteriorated canals require pouring of new reinforced concrete against the existing structure. A CARPI CL liner is embedded into the new concrete walls. The low coefficient of friction of the CARPI liner allows the water flow capacity of the canal to increase despite the reduction in the cross section due to the thickness of new concrete and liner.

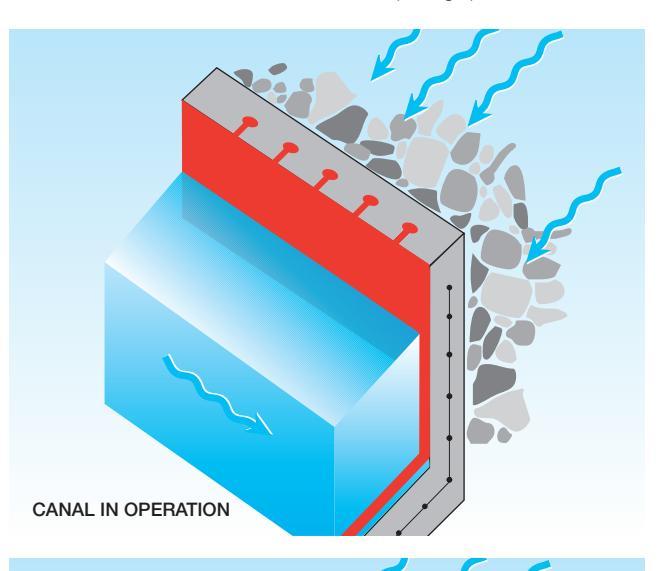
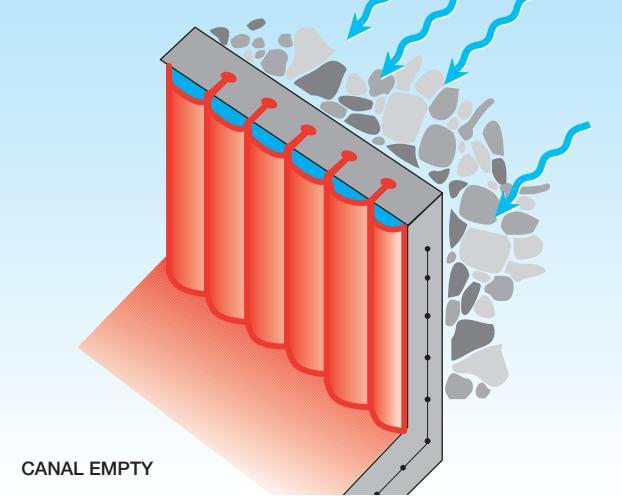
Elasticity and embedded ribs of CL geomembrane allow discharge of uplift pressure when canal is empty.

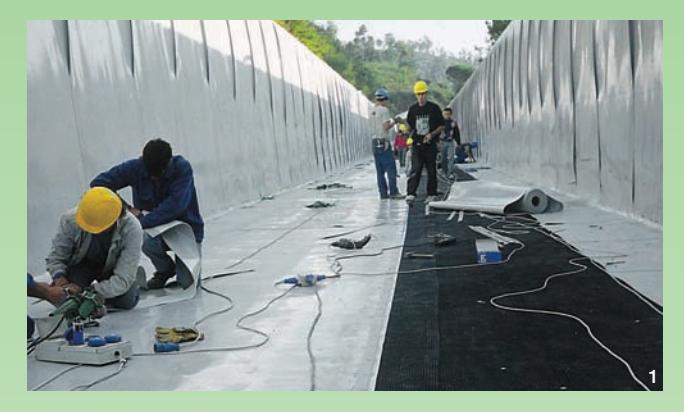
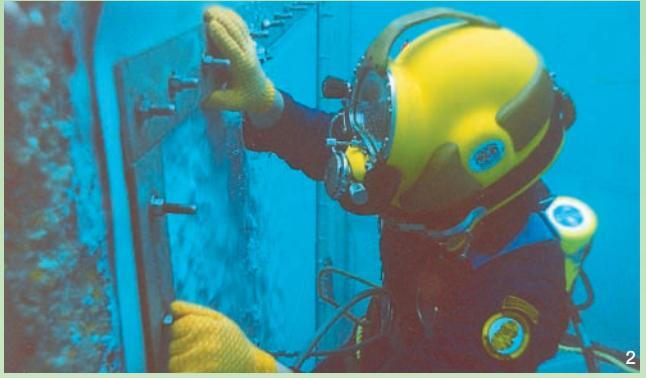
- 1 Installation of the waterproofing PVC geomembrane over the drainage layer.
- 2 The CARPI waterproofing geomembrane systems can also be installed underwater eliminating the need to dewater the facility.
- 3 Recommended surface preparation: hydroblasting to eliminate loose surface material. The CARPI geomembrane system reduces installation costs by dramatically reducing surface preparation costs.
- 4 Construction of drainage collection system: installation of a geonet on the inner walls and bottom, construction of longitudinal drainage pipe embedded in the invert.
- 5 Geomembrane sheet installed longitudinally over the subgrade. Frequently no synthetic drainage layer is required in small cross section canals.
- 6 Geomembrane sheet installed over the synthetic drainage layer (i.e.: geonet).

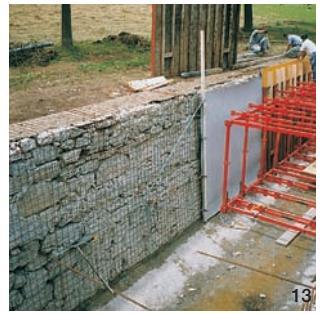
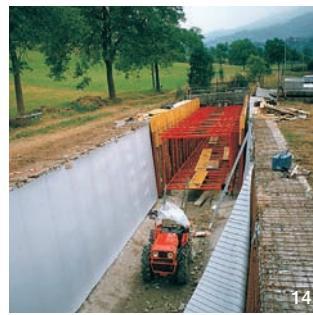
- 13 The CL geomembrane sheets are placed over steel reinforcement mesh, against formwork, before concrete pouring.
- 14 Formworking proceeds as new walls embedding CL geomembrane are constructed.

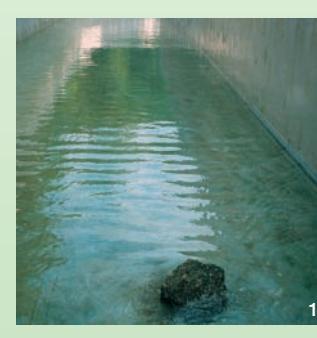
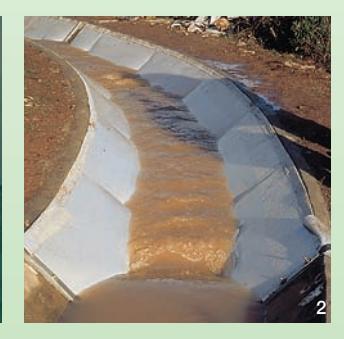
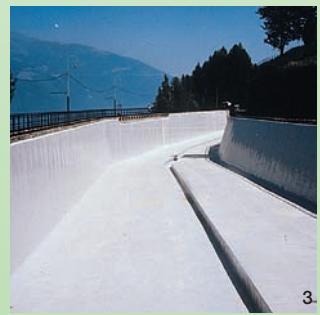
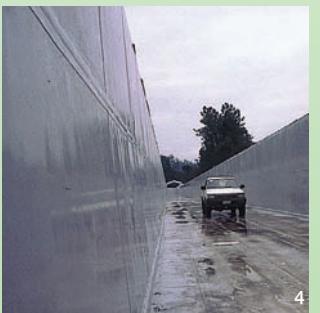
- Resistance to impact: rocks that fall into the canal roll over the geomembrane and are transported by the flow. The geomembrane has been tested to verify its ability to withstand severe impacts.
- 2 Low hydraulic roughness: increase in water flow due to installation of the geomembrane and reduction in liner uplift pressures due to the drainage system behind the geomembrane.
- 3 High resistance to ultraviolet rays: the CARPI geomembrane is custom formulated to withstand ultraviolet radiations. Laboratory tests performed on samples from existing installations, that have been in service more than 20 years, show no significative change in geomembrane characteristics, signifying the geomembrane waterproofing life will easily exceed 50 years.
- 4 High resistance to mechanical stresses. CARPI does not recommend driving cars on geomembranes, but it is done and it works!

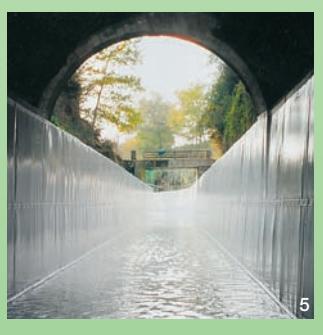
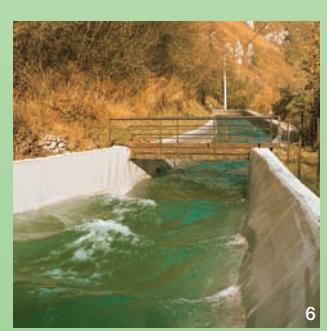
- 5 After installing the CARPI geomembrane system this canal had a documented increase in water flow capacity (from 10 to 19 $m^3/sec).$
- 6 High resistance to water velocity: CARPI's patented mechanical anchorage system for the geomembrane allows it to withstand water velocities in some cases up to 10 meter/sec.

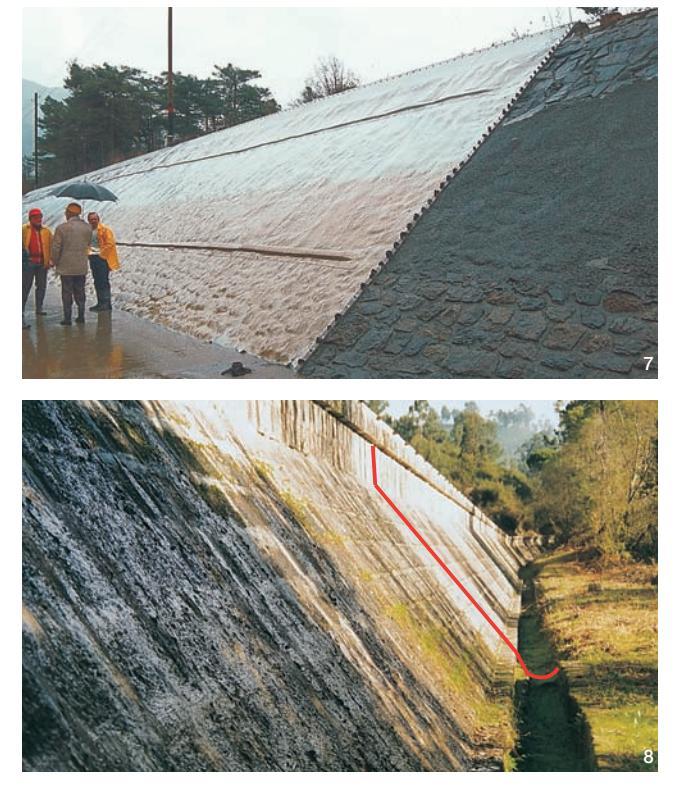
- 7 High resistance to puncturing and burst: CARPI geomembrane system has been installed on very aggressive substrates without any deterioration in performance. Extensive laboratory tests have been conducted on sample substrates to verify geomembrane system robustness.
- 8 Complete watertightness: the red line in the picture marks the end of the canal waterproofed with the CARPI geomembrane system (in further distance), showing the desaturation effect of a drained geomembrane liner.

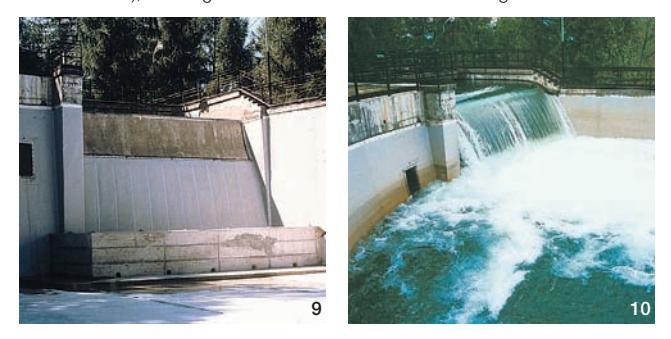
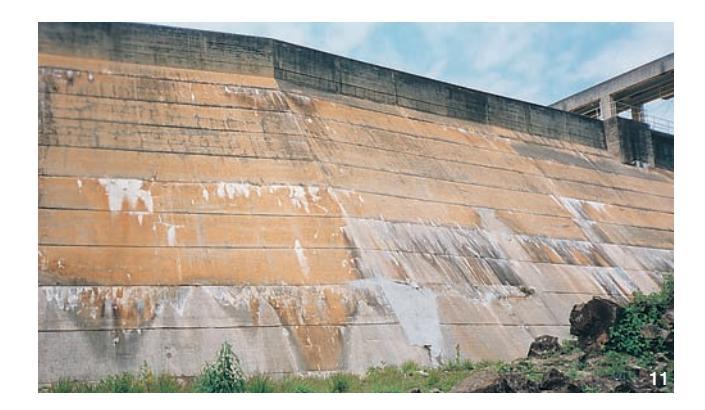
- 9/10 High resistance to turbulence and suction depends on appropriate design and thorough quality control during installation (photo 9, immediately after construction, photo 10 after 7 years of service).
 - 11 Watertightness: the CARPI system provides a cost effective long lasting solution to leakage. The photo shows how the CARPI geomembrane system eliminated the leakage shown on page: Problems, photo 3, left.

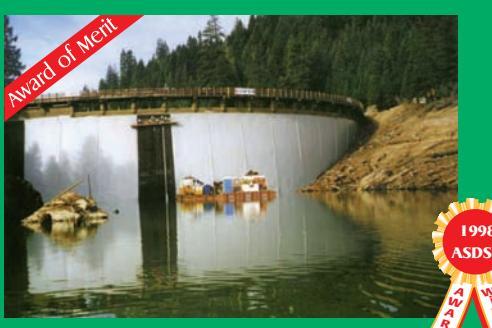
Underwater installation on Lost Creek dam - USA Winner of the 1998 West Region Award of Merit from the Association of State Dam Safety Officials (ASDSO)
